Manhole Inspection Summary

Manhole # S11CC2005MH

Insp Date: **7/27/06 9:15 AM**

Location Address: **2208 ARDEN RD**

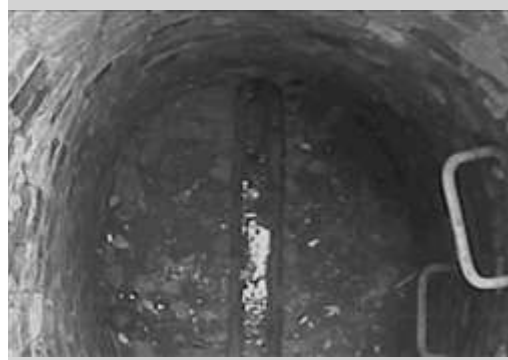
Top View

Corroded steps. Evidence of surcharge - Bench debris.

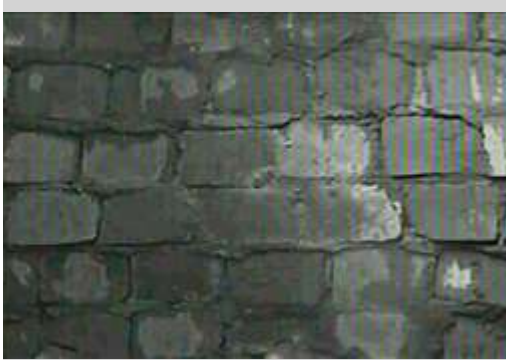
Defect

Corbel infiltration.

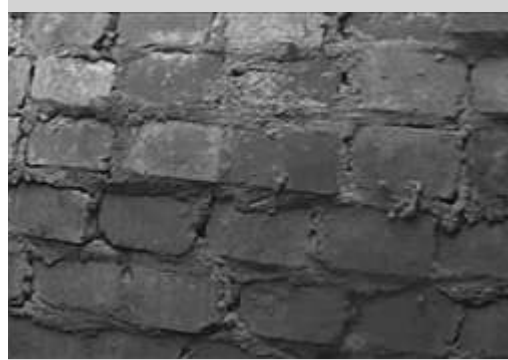
Defect

Barrel infiltration.

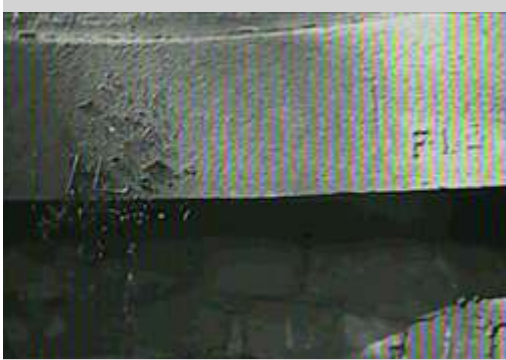
Defect

Frame leaks. Corbel infiltration.

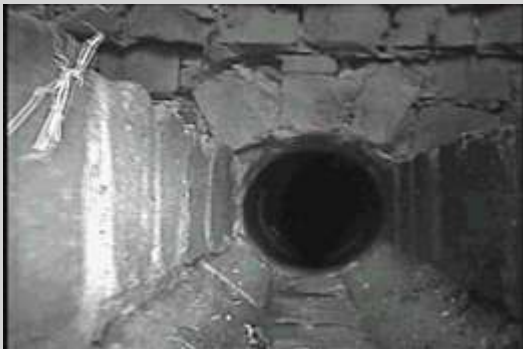
6 in. Circular Gravity Sewer Pipe In @ 6 O'Clock

Barrel deterioration and infiltration. Channel deterioration.
